HOUSATONIC RIVER BASIN
HINSDALE, MASSACHUSETTS

UPPER SACKETT RESERVOIR DAM
MA 00227

PHASE I INSPECTION REPORT
NATIONAL DAM INSPECTION PROGRAM

AUGUST 1981

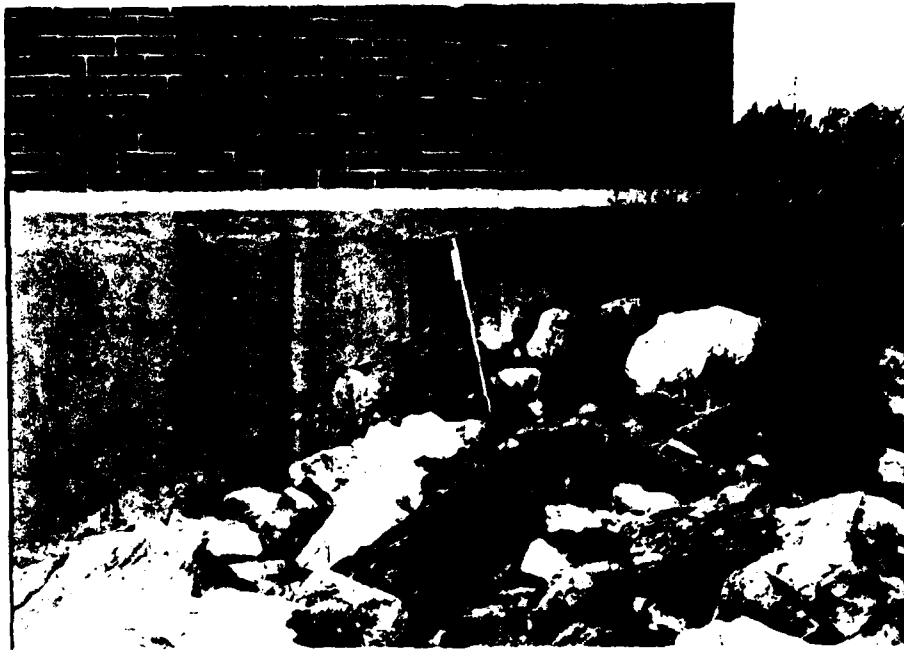
the upstream slope may have subsided somewhat, as shown in photograph 11. It appears that the foundation wall of the gate structure was resurfaced with mortar in the past and that the riprap has settled as much as 10 inches below the area that was resurfaced.

PHOTO NO. 11 - Base of gate structure where masonry finish on gate structure suggest that settlement of crest has occurred. However, subsidence in this area not obvious.
